118 E. Hillside Avenue – Contributing

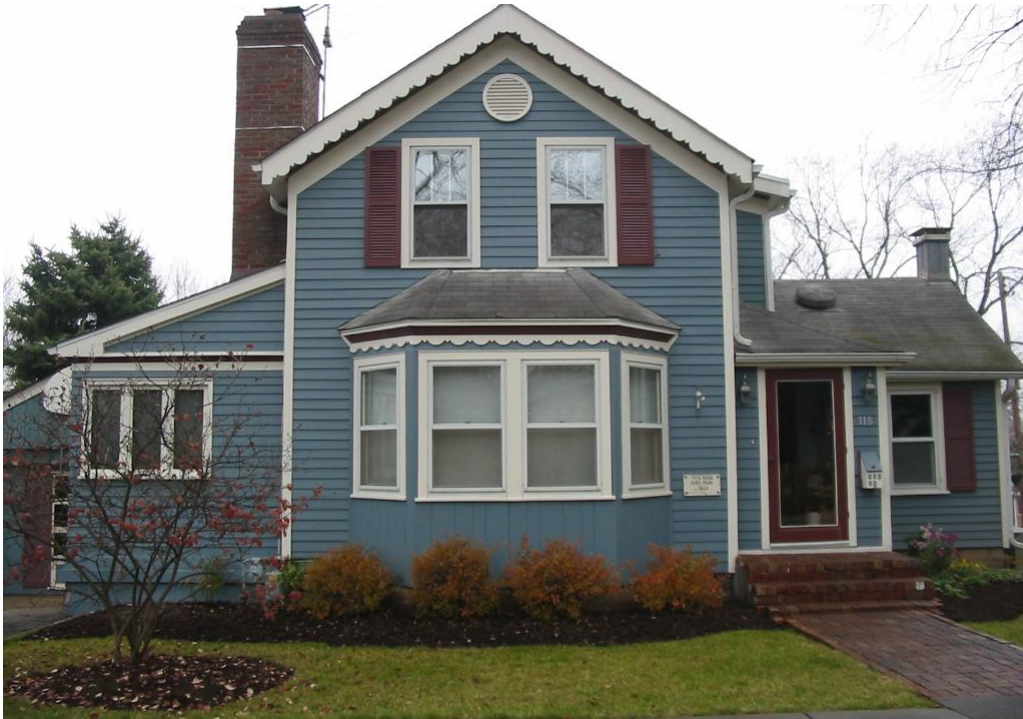
At this location is a ca. 1869 house, according to the sign on the outside, however there is no indication of that date, as the house was extensively remodeled ca. 1990.

The house is a two-story, frame, gable front dwelling with an asphalt shingle roof, a concrete block and poured concrete foundation, a newly built or rebuilt brick chimney and an exterior of new weatherboard siding. A small shed roof lateral addition has been added to the west elevation and has a large picture window and single-light fixed windows. A recently constructed garage is to the west of the dwelling and appears to be attached. The main façade has an added bay window and ca. 1990, one-over-one double hung vinyl sash and original, three-over-one vertical-light double hung wood sash windows. A small entry bay has been added to the main and east façade with a ca. 1990, glass and wood door. Large shed roof and gable roof extensions have been added to the east elevation. This elevation also has a newly constructed wood deck.

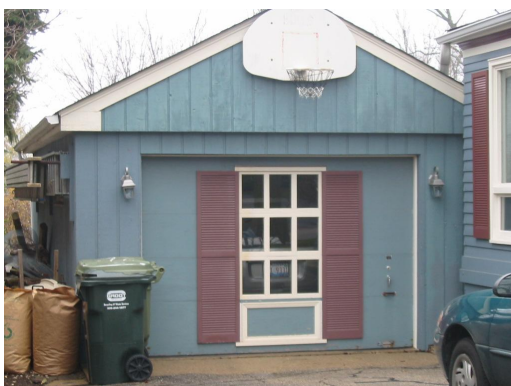
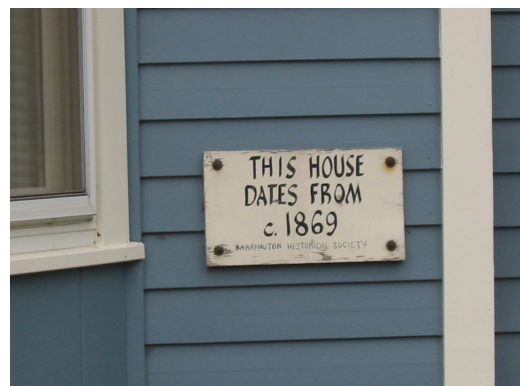
The garage, if considered a separate structure, is **Non-contributing**
